Measures to enhance the Climate Resilience of Hydropower

IEA Hydro Task 17

October 2025

REPORT # INFORMATION

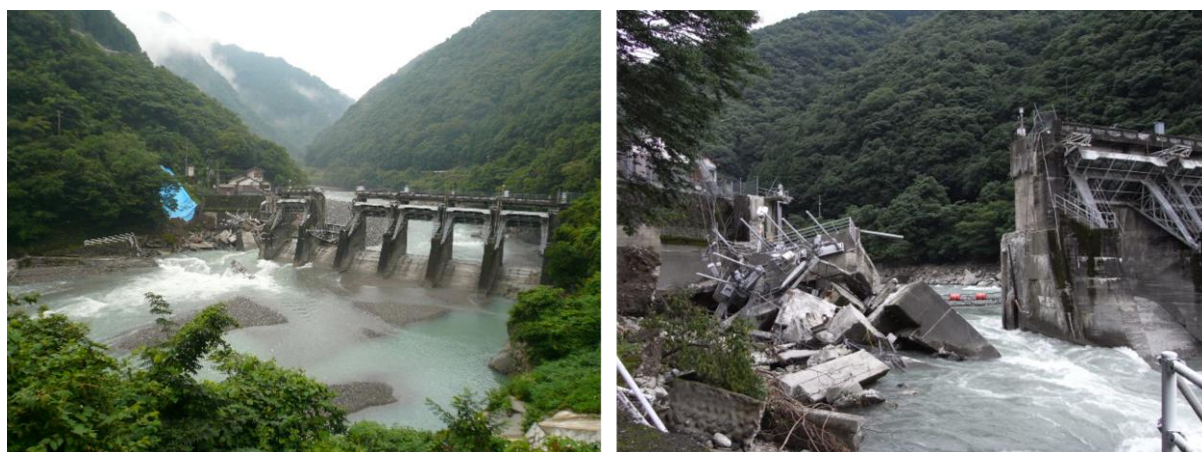
Figure 3-1 Flood Damage Cases at Kyushu EPCO's Kawabegawa No.1 Power Plant (Left: Damage to Intake, Right: Enlarged View of the Right Bank Slope)

2-14 (Example of Flood Damage) Kawabegawa No.1 Power Plant	It was restored by converting to a rubber tube weir (rubber weir), considering cost-effective, reliability of operation, and simplify of management. Regarding the cutoff wall, in addition to ensuring the length of the seepage path, steel sheet piles were driven down to the bedrock on both the upstream and downstream sides to prevent erosion and piping caused by the movement and scouring of the structure's foundation.	The anticipated future flood risk : none. Renovation and modification plans for power generation facilities : none. Review of operation and maintenance management : The cause of the disaster was related to structural issues.	Out of the target of this study as shown in Figure 3-3	Flood
2-31 (Example of Flood Damage) Kumakawa Power Plant	In the restoration of the intake dam embankment, temporary cofferdams were constructed within the river, and the original shape was restored by using concrete. For the side walls of the spillway overflow channel, embedded formwork was used to eliminate the need for temporary scaffolding to facilitate early recovery and the original shape was restored by using concrete.	The anticipated future flood risk : none. Renovation and modification plans for power generation facilities : none. Review of operation and maintenance management : none.	Out of the target of this study as shown in Figure 3-3	Flood

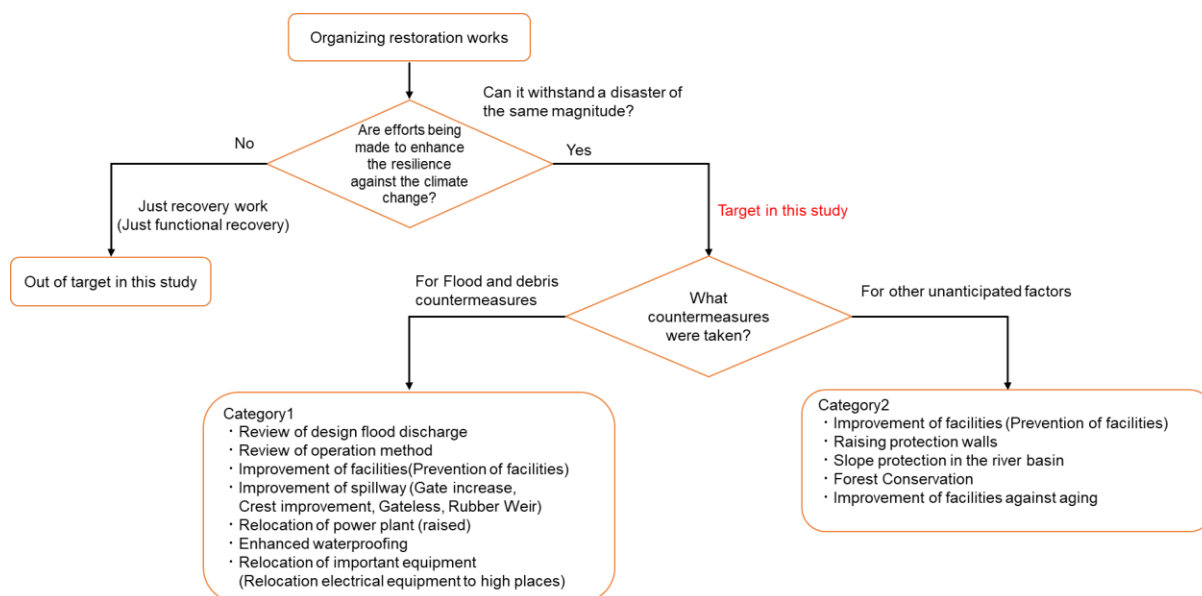
Next, we categorize the countermeasures against the damages organized in Figure 3-3 based on their aim to enhance resilience to climate change. The categorization is shown in Figure 3-4. If it includes measures to strengthen resilience to climate change, it can be considered a resilience enhancement measure to climate change.

Figure 3-4 Organizing Countermeasures

Construction of Bypass Channel of Kurobuchi Dam, No.2. Nishiyosino Power Plant	Out of the target of this study as shown in Figure 3-4	N/A

Name of the project	Resilience enhancement measures	
	Flood exceeding the design flood discharge	floods by unanticipated events
2-20 Recovery works of Uenogawa Intake Weir Sukawa Power Plant	<ul style="list-style-type: none"> Review of Design Flood Discharge Installation of new gravity type intake weir at downstream of existing intake weir and maintenance of attaching apron works and protection walls 	N/A
2-21 (Example of Flood Damage) Yuyama Power Plant	<ul style="list-style-type: none"> Review of Design Flood Discharge · Raising the level of the inspection house (control device of waterway, storage of the tools for the maintenance) Relocation of the control devices including cable duct to the higher place. Strength of waterproofing capability 	N/A
Protection sheet against Turbid water in Sakuma reservoir, Sakuma Power Plant	Out of the target of this study as shown in Figure 3-4	N/A
Construction of surface intake facilities of Sakamoto Dam, Owase No.1 Power Plant	Out of the target of this study as shown in Figure 3-4	N/A

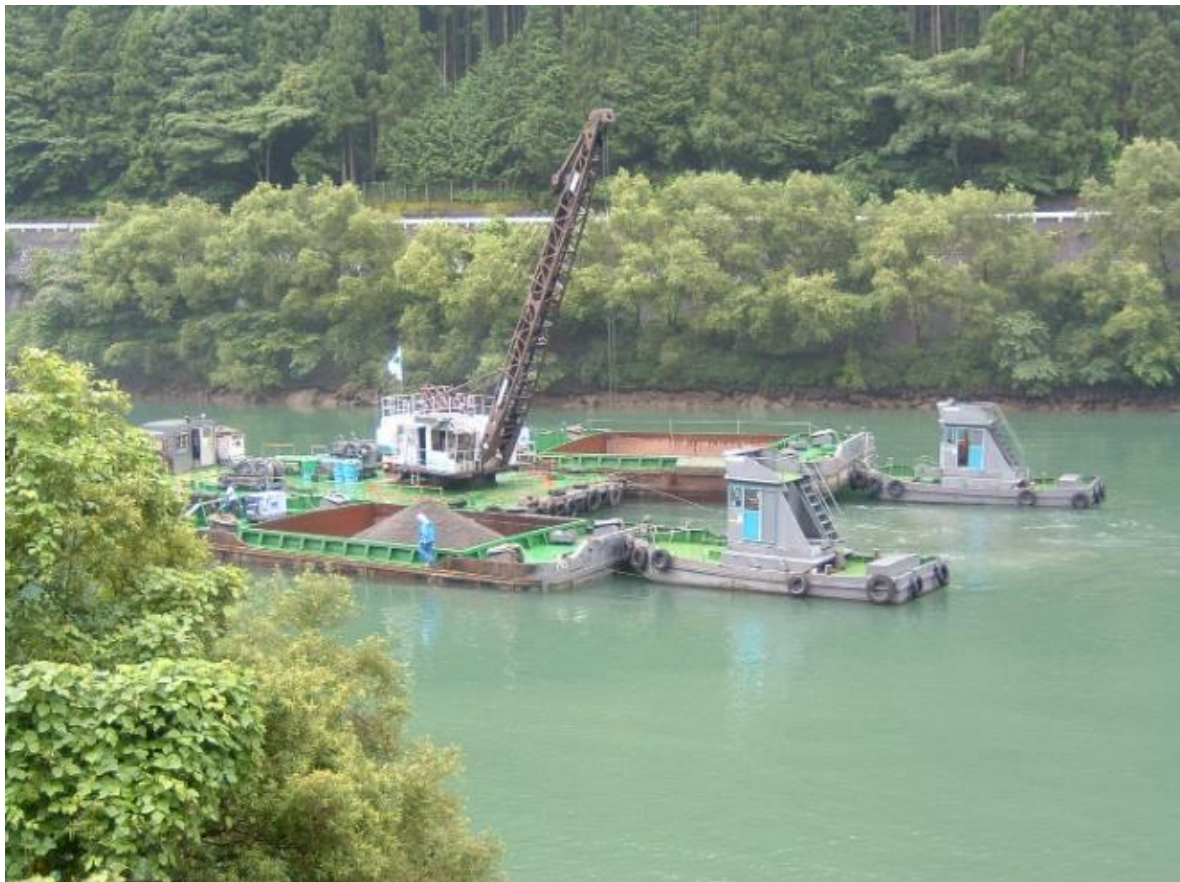
Figure 4-1 Dredging at Sakuma Dam, J-Power

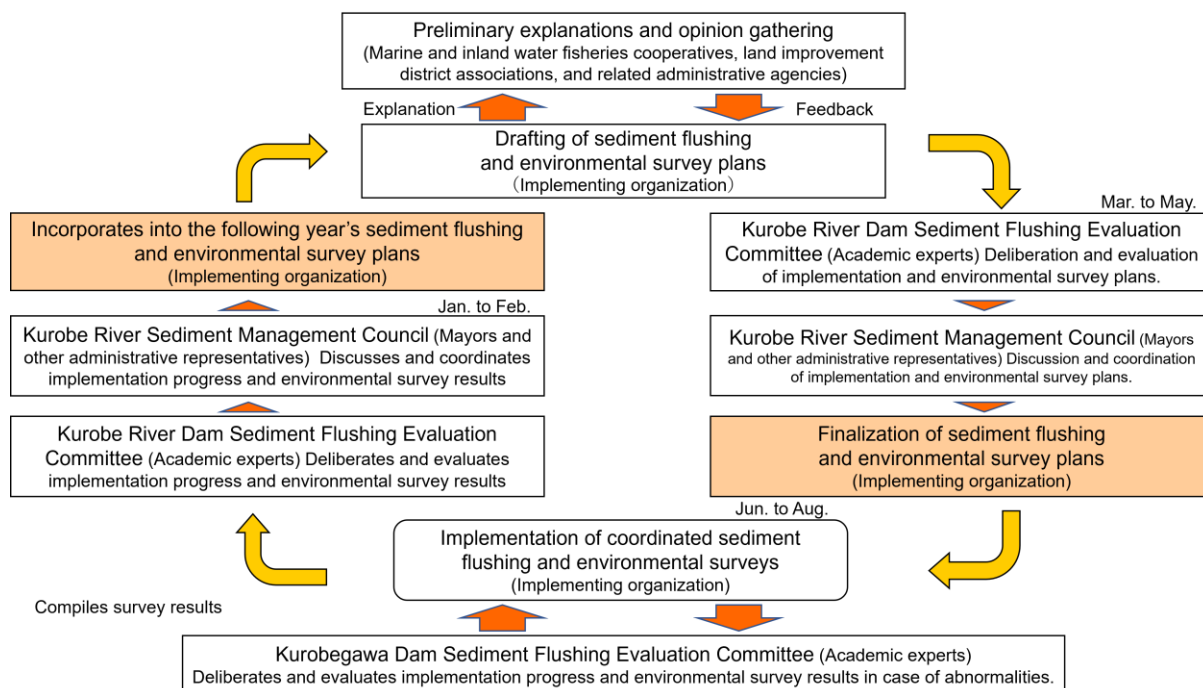
Since 2010, continuous and regular monitoring of water quality, sediment, and aquatic organisms has been conducted annually. The following diagram illustrates the process from implementing coordinated sediment flushing to evaluation monitoring.

Figure 4-5 Flow of Coordinated Sediment Flushing Implementation Plan and Evaluation Monitoring

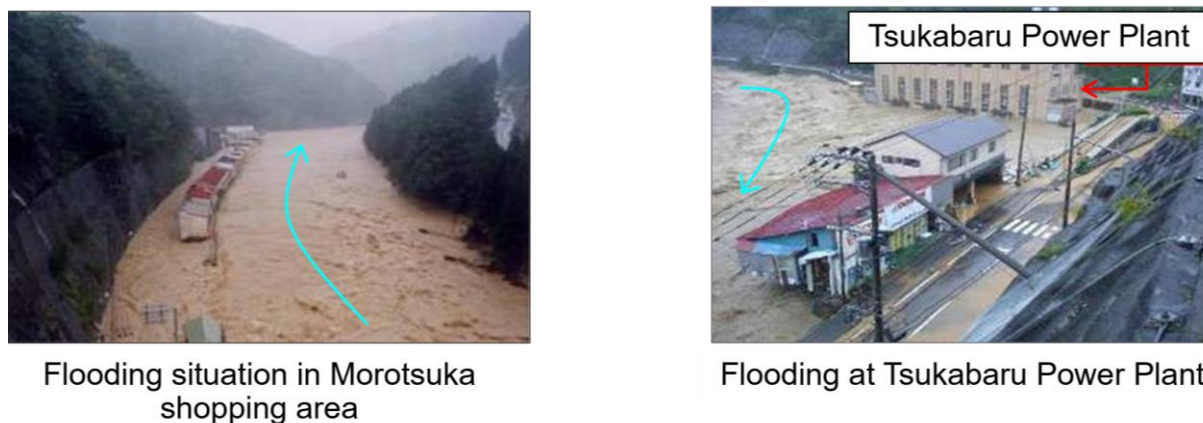
In the central area of Morotsuka, upstream of the Yamasubaru Dam regulating reservoir, a record seventy (70) houses were flooded. Four (4) power plants (Kamishiiba, Tsukabaru, Yamasubaru, and Saigo) became inoperable due to flooding. Overflow occurred at three (3) dams, and the dam management offices (Tsukabaru, Yamasubaru, and Saigo) were inundated.

Figure 4-9 Status of Flooding Damage

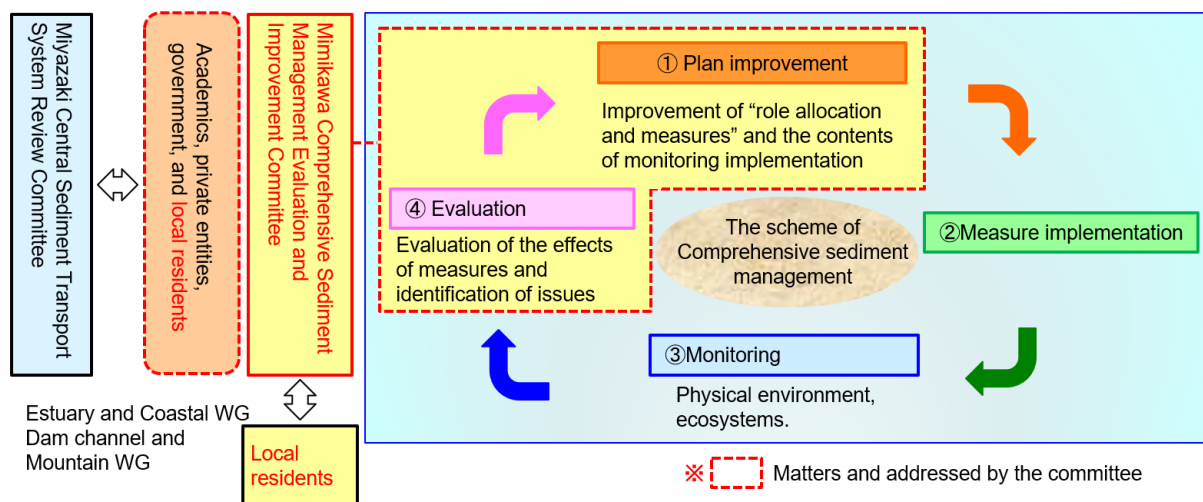
Based on these evaluations, the action plans in the next step are continuously improved. To facilitate this adaptive management approach, the "Evaluation and Improvement Committee" was established in July 2012, replacing the original "Technical Review Committee." This committee includes the participation of experts, private entities, government officials, and local residents.

Figure 4-11 Sediment Management of the Mimikawa River System

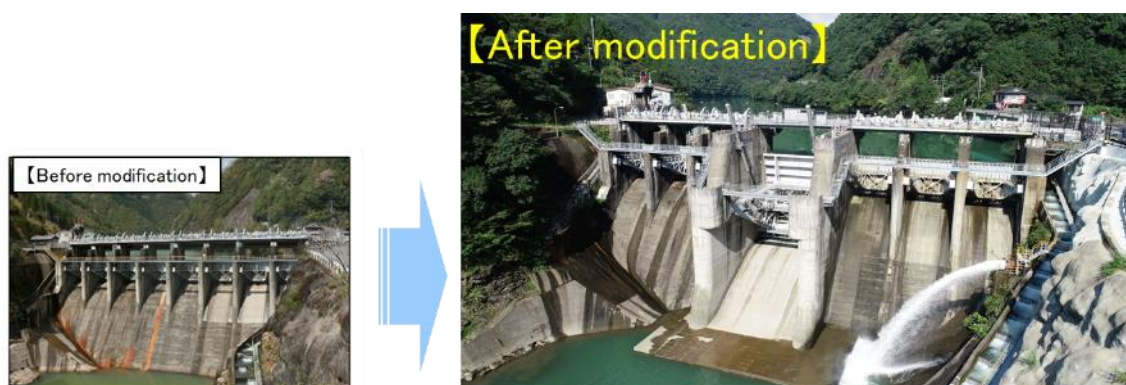
At Yamasubaru Dam, two (2) of the eight (8) existing radial gates were removed from the center, and the overflow crest was lowered by approximately 9 meters. A single radial gate was then installed to facilitate sediment flushing.

Figure 4-16 State of Yamasubaru Dam Before and After Modifications

The previous structures of the Yamasubaru Dam and Saigo Dam were unable to efficiently flush sediment during floods. Therefore, modification work was carried out to partially lower the height of the existing dams within structurally feasible limits.

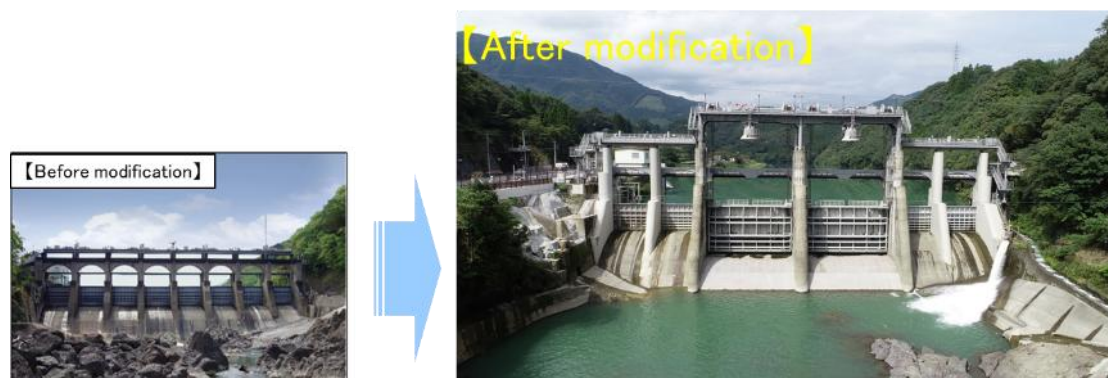
At Saigo Dam, four (4) of the eight (8) existing roller gates in the center were removed, and the overflow crest was lowered by approximately 4 meters. Two (2) new roller gates were installed to improve sediment flushing capabilities.

Figure 4-17 State of Saigo Dam Before and After Modifications

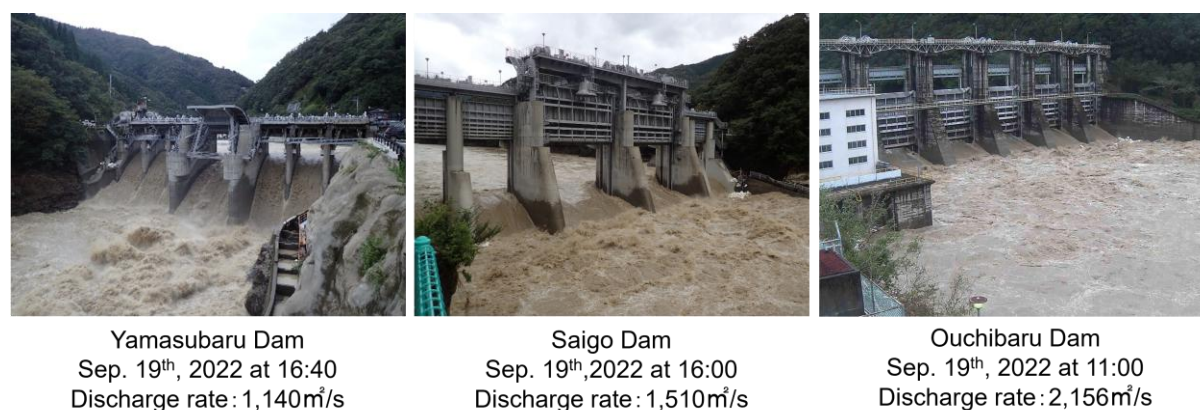
Figure 4-24 Picture of the 3-Dams Coordinated Sediment Flushing Operation

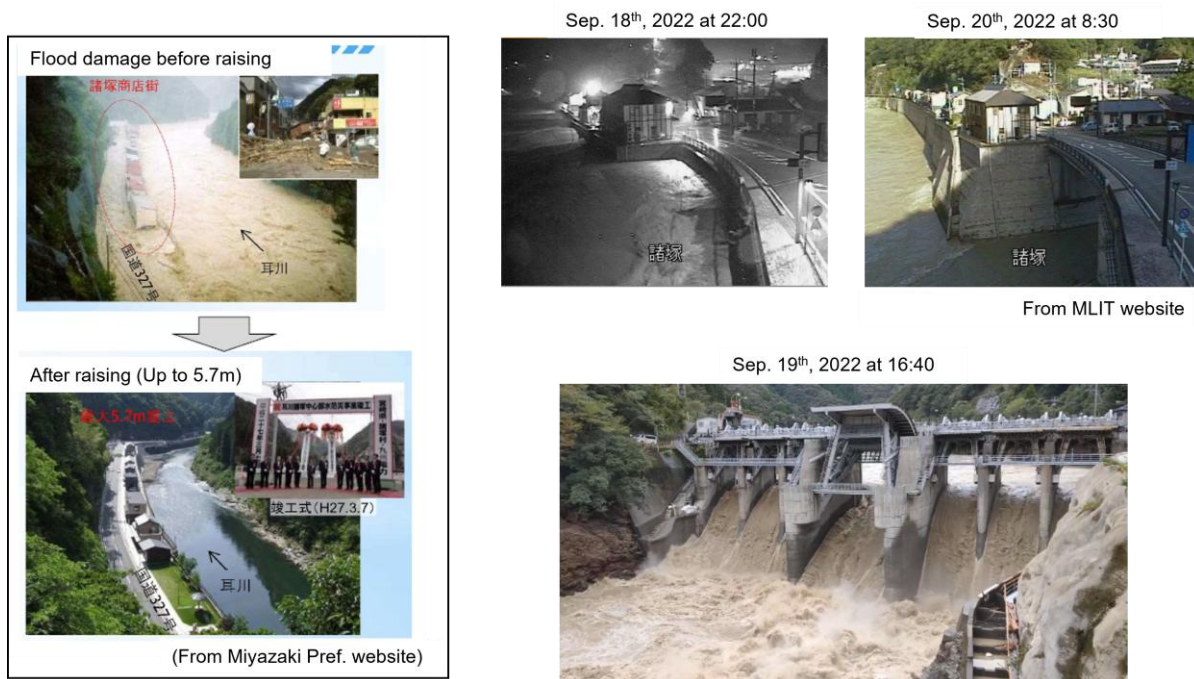
The central area of Morotsuka, which experienced flooding during Typhoon No.14 in 2005, avoided significant flood damage due to sediment flushing operations, embankment raising, and sediment relocation efforts.

Figure 4-25 Effects of Dam Sediment Flushing Operations

Flood Control: Improved flood safety was observed in some upstream reservoir areas, with sediment movement leading to a reduction in riverbed elevation.
