# Measures to Enhance the Climate Resilience of Hydropower

IEA Hydro Task 17

December 2025

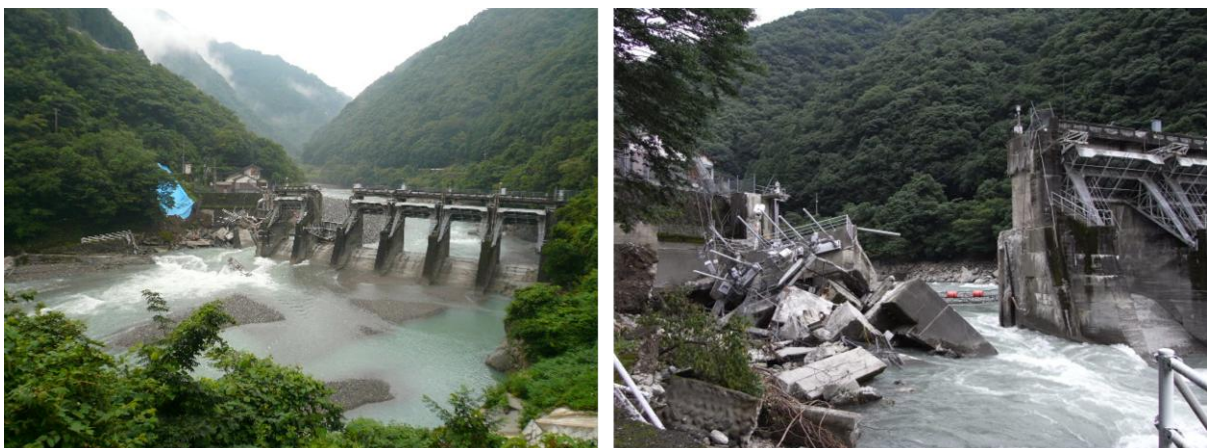
Figure 3-1 Flood Damage Cases at Kyushu EPCO's Kawabegawa No.1 Power Plant (Left: Damage to Intake, Right: Enlarged View of the Right Bank Slope)

2-14 (Example of Flood Damage) Kawabegawa No.1 Power Plant	It was restored by converting to a rubber tube weir (rubber weir), considering cost-effective, reliability of operation, and simplify of management. Regarding the cutoff wall, in addition to ensuring the length of the seepage path, steel sheet piles were driven down to the bedrock on both the upstream and downstream sides to prevent erosion and piping caused by the movement and scouring of the structure's foundation.	The anticipated future flood risk : none. Renovation and modification plans for power generation facilities : none. Review of operation and maintenance management : The cause of the disaster was related to structural issues.	Out of the target of this study as shown in Figure 3-3	Flood
2-31 (Example of Flood Damage) Kumakawa Power Plant	In the restoration of the intake dam embankment, temporary cofferdams were constructed within the river, and the original shape was restored by using concrete. For the side walls of the spillway overflow channel, embedded formwork was used to eliminate the need for temporary scaffolding to facilitate early recovery and the original shape was restored by using concrete.	The anticipated future flood risk : none. Renovation and modification plans for power generation facilities : none. Review of operation and maintenance management : none.	Out of the target of this study as shown in Figure 3-3	Flood

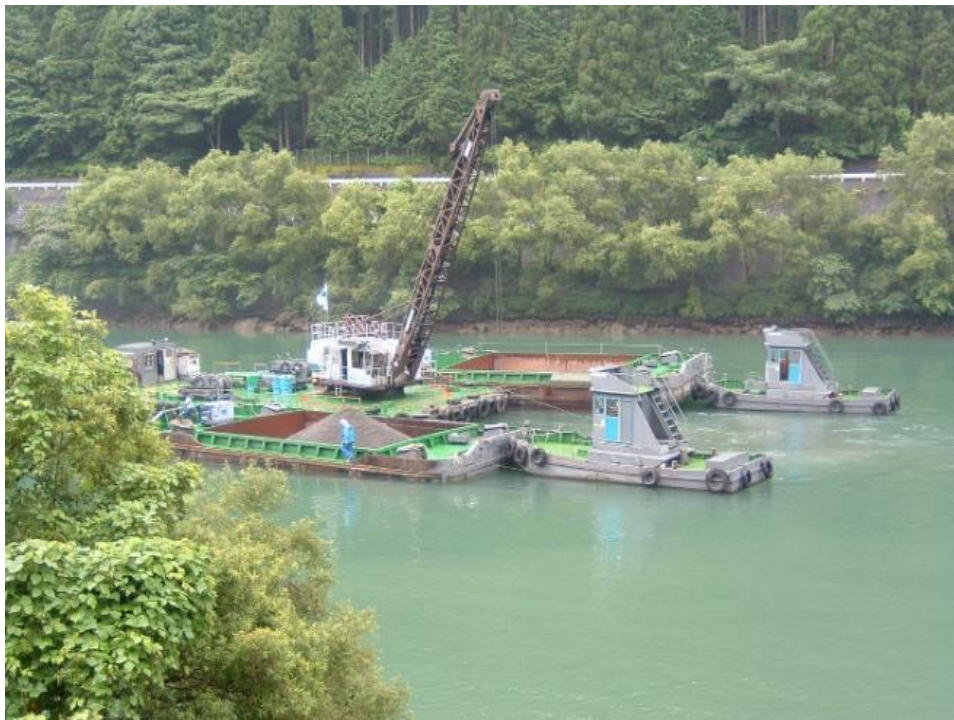
Figure 4-1 Dredging at Sakuma Dam, J-Power

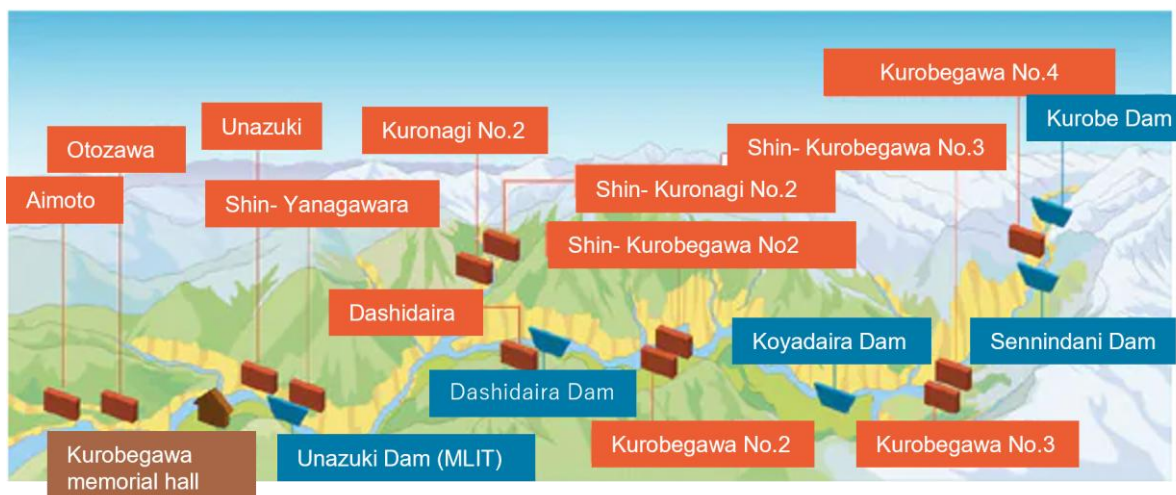
On the other hand, the abundant rainfall frequently causes floods in the Kurobe River. Known as one of Japan's steepest rivers, it carries a large amount of sediment during floods, resulting in significant sediment runoff per unit area of the basin. At the Dashidaira Dam, completed in 1985, securing sediment storage capacity was difficult, and a sediment flushing plan was implemented from the outset.

Figure 4-3 Power Generation Facilities in the Kurobe River System

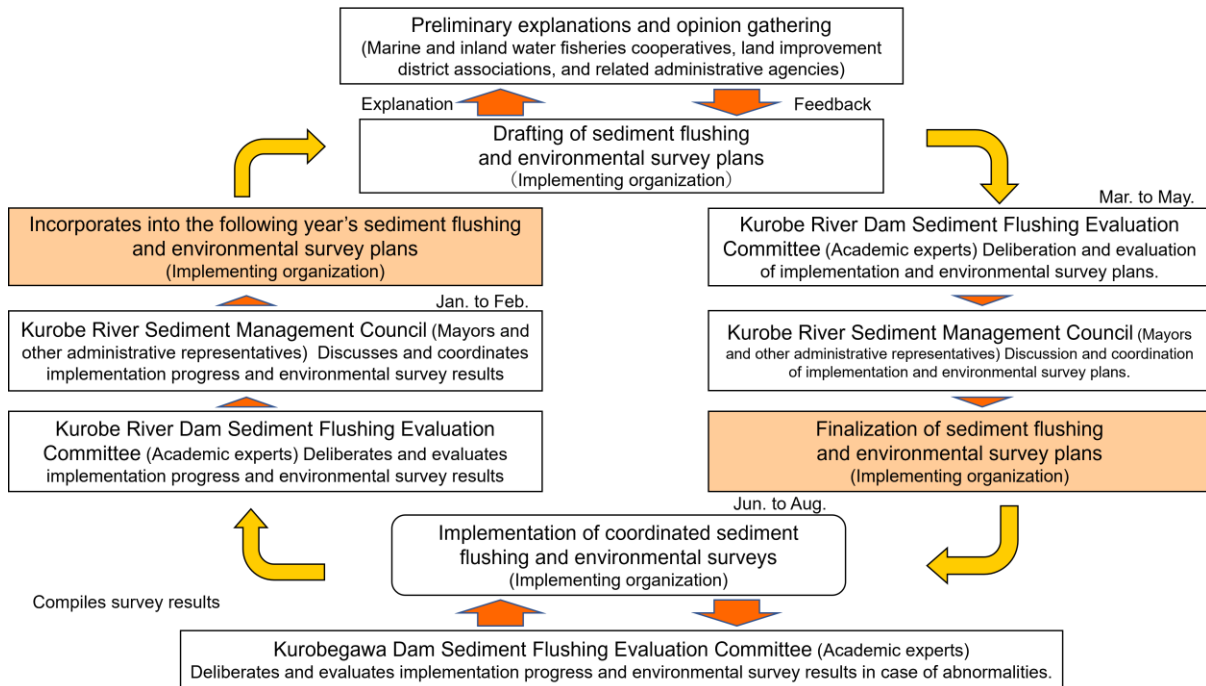
Since 2010, continuous and regular monitoring of water quality, sediment, and aquatic organisms has been conducted annually. The following diagram illustrates the process from implementing coordinated sediment flushing to evaluation monitoring.

Figure 4-5 Flow of Coordinated Sediment Flushing Implementation Plan and Evaluation Monitoring

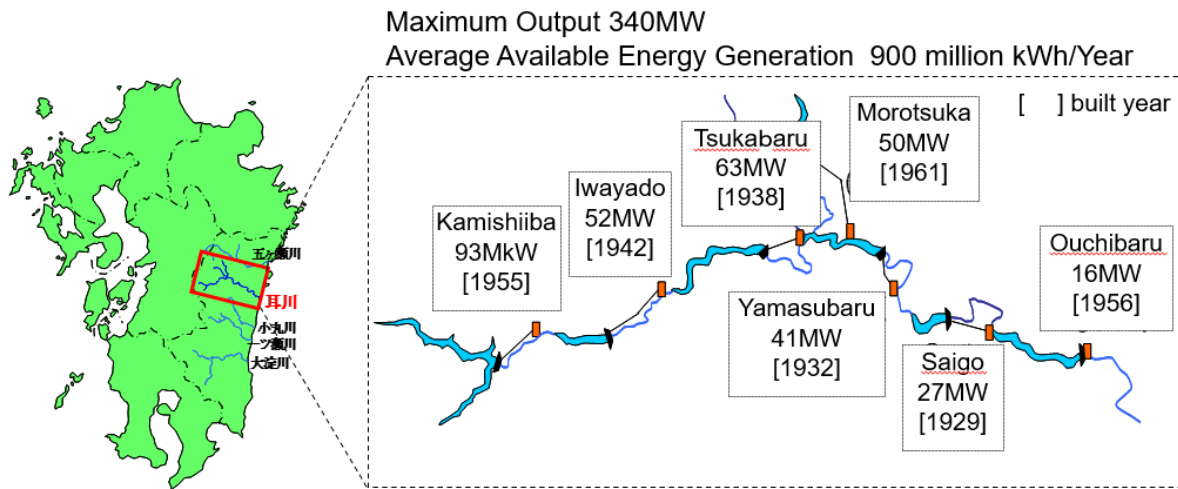
The Mimikawa river system is located in the northern part of Miyazaki Prefecture. It is a power supply river system with seven (7) hydropower plants, accounting for more than 20% of Kyushu Electric Power's general hydroelectric capacity and generation. The basin is blessed with steep mountains and abundant water flow, and power generation has been

Figure 4-6 Overview of Mimikawa River System

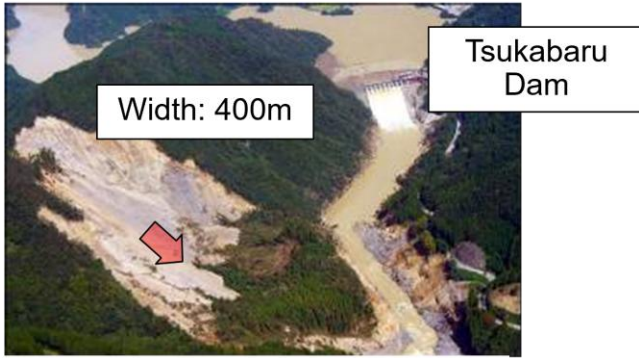
Figure 4-8 Status of Slope Collapses

- (1) Slope collapse:  
Numerous slope collapses occurred, resulting in a massive inflow of sediment into the rivers. A total of 10.6 million m<sup>3</sup> of sediment flowed in, with half of that (5.2 million m<sup>3</sup>) accumulating in the reservoirs.

Collapse situation downstream of Tsukabaru Dam

Collapse in the regulating reservoir of the Yamasubaru Dam

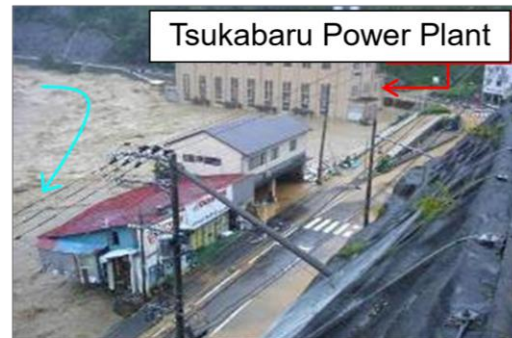
Figure 4-9 Status of Flooding Damage

In the central area of Morotsuka, upstream of the Yamasubaru Dam regulating reservoir, a record seventy (70) houses were flooded. Four (4) power plants (Kamishiiba, Tsukabaru, Yamasubaru, and Saigo) became inoperable due to flooding. Overflow occurred at three (3) dams, and the dam management offices (Tsukabaru, Yamasubaru, and Saigo) were inundated.

Flooding at Tsukabaru Power Plant

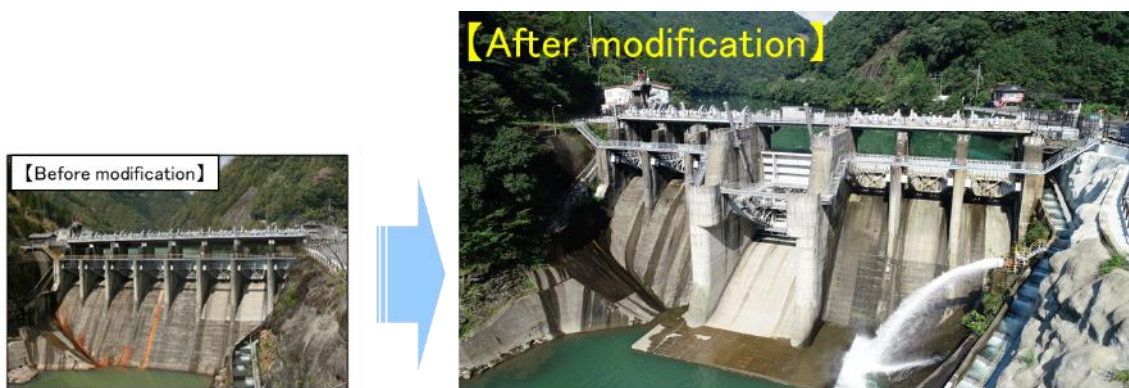
At Yamasubaru Dam, two (2) of the eight (8) existing radial gates were removed from the center, and the overflow crest was lowered by approximately 9 meters. A single radial gate was then installed to facilitate sediment flushing.

Figure 4-16 State of Yamasubaru Dam Before and After Modifications

The previous structures of the Yamasubaru Dam and Saigo Dam were unable to efficiently flush sediment during floods. Therefore, modification work was carried out to partially lower the height of the existing dams within structurally feasible limits.

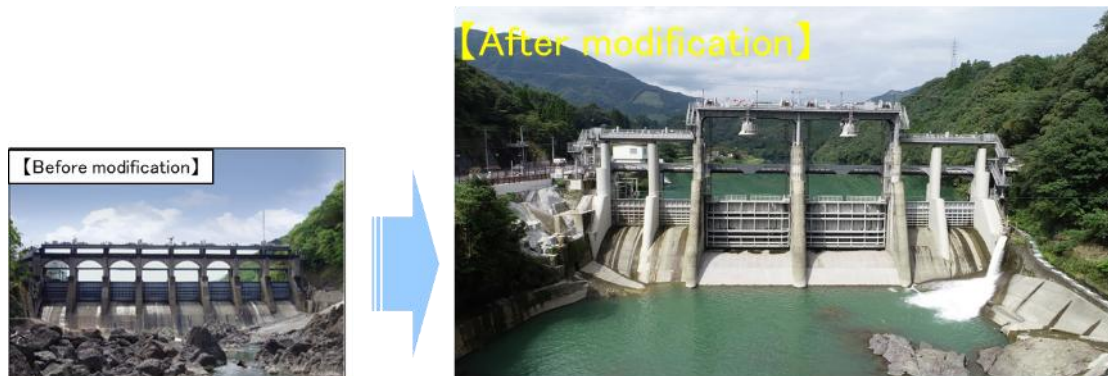
At Saigo Dam, four (4) of the eight (8) existing roller gates in the center were removed, and the overflow crest was lowered by approximately 4 meters. Two (2) new roller gates were installed to improve sediment flushing capabilities.

Figure 4-17 State of Saigo Dam Before and After Modifications

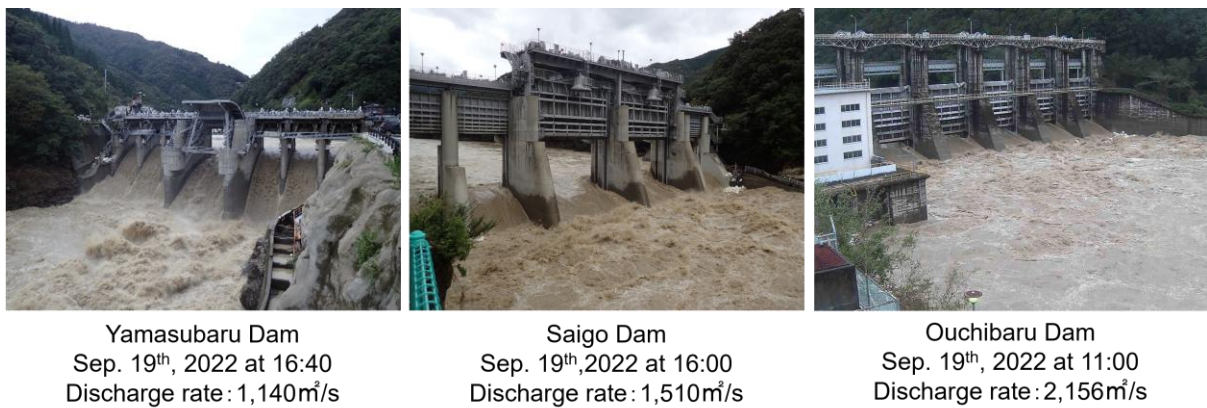
Yamasubaru Dam  
Sep. 19<sup>th</sup>, 2022 at 16:40  
Discharge rate: 1,140m<sup>3</sup>/s

Saigo Dam  
Sep. 19<sup>th</sup>, 2022 at 16:00  
Discharge rate: 1,510m<sup>3</sup>/s

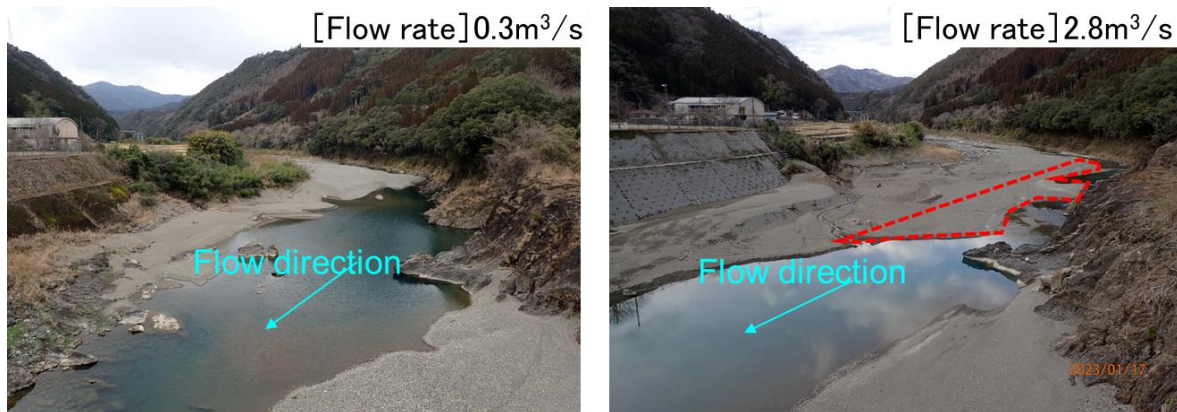
Downstream of the dam, increased diversity in riverbed materials and clearer distinctions between riffles and pools have been observed. In the area circled by the red dot on the right figure, we can observe a sandbar formed by sediment supplied from upstream through the dam.

Figure 4-26 Comparison of the Situation 1 km Downstream of Saigo Dam (Left: Before Sloughing, Jan.12th, 2022. Right: After Sloughing, Jan. 17<sup>th</sup>, 2023)

Previously, sediment trapped by the dam caused riverbed materials to coarsen. Through sediment flushing, a variety of particle sizes, such as stones, gravel, and sand, are supplied downstream. This process also leads to the expansion of sandbars and the formation of distinct riffles and pools, helping the river return to its natural state.

Environmental Improvement: Downstream of Yamasubaru Dam, Saigo Dam, and Ouchibaru Dam, sediment of various sizes was observed to move, and changes in riffles and pools were noted compared to conditions before sediment flushing.
